ERDC/EL TR-01-18

S-Tracker Survey of Sites for Long-Term Erosion/Deposition Monitoring

Final report

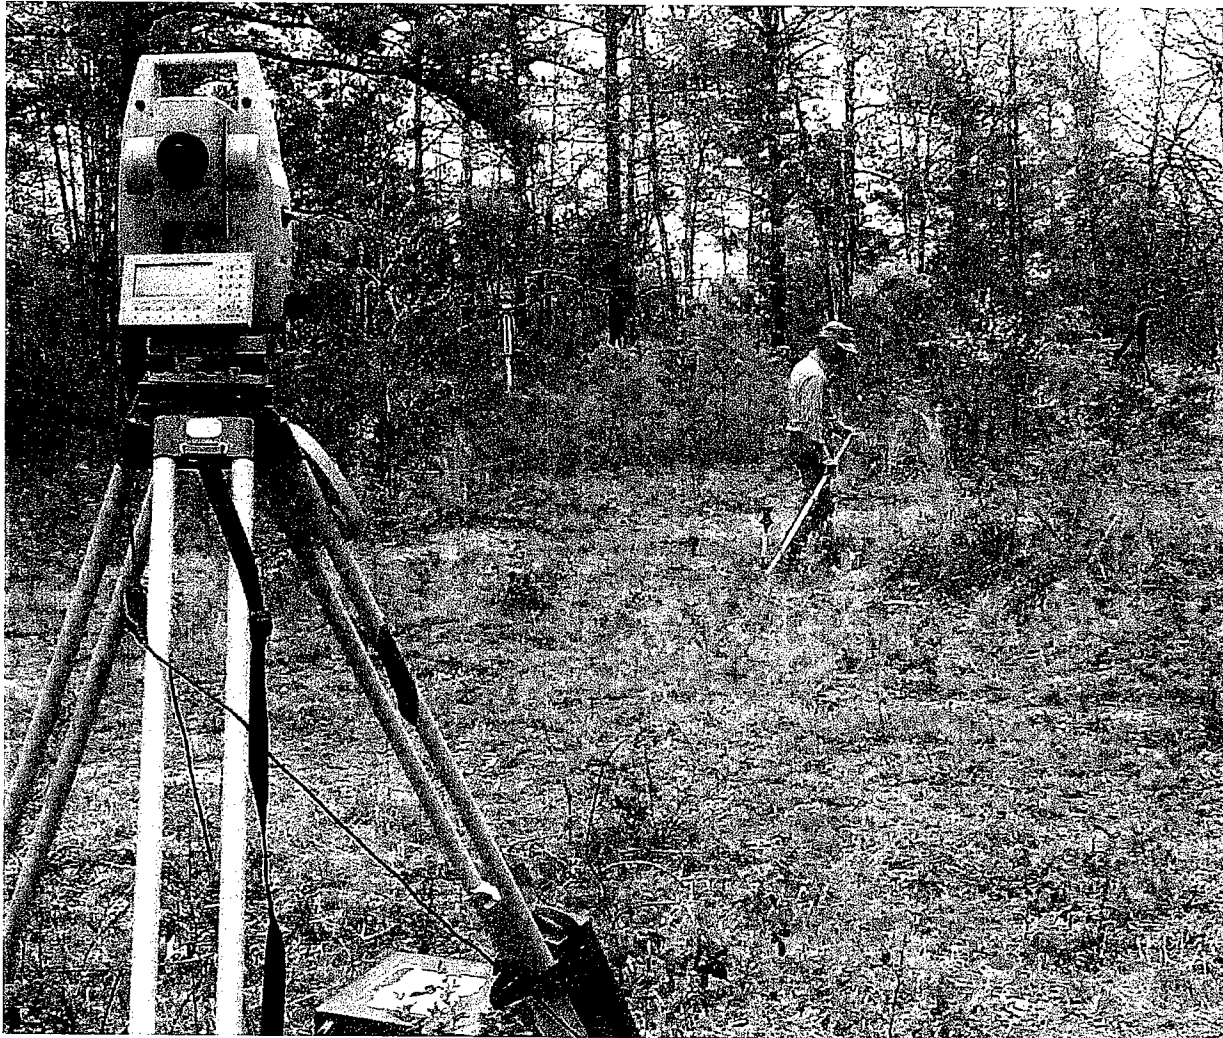
Figure 1. S-Tracker system with two instruments

¹ S-Tracker is an integrated hardware/software laser survey system that uses two or more robotic electronic theodolites and an optionally real-time kinematic global positioning system (GPS) to track sensor platforms with a prism moving over a course.

First all instruments were set up, leveled, and plumbed over the control point. Two instruments were connected with the field computer via radio modems, with the third directly connected with a serial cable. Each instrument was then aimed at the backsite prism. Then, each individual instrument was oriented using the back-site and the instrument position fine-tuned to return the correct backsite position within ± 1 mm. These adjustments were generally very small (< 2 cm typically). The instruments were then sighted on the prism on the wheel for the topography measurements. Alternate colored flags were placed on the sides parallel to the slope of the site at 0.5-m intervals to guide survey transects. Guide strings were placed across the site at 5-m intervals to provide a visual reference

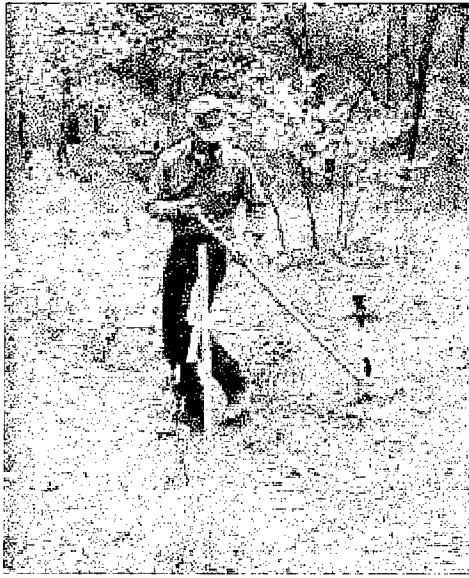
Figure 2. Prism on wheel

operator. The wheeled prism was then pulled across the site perpendicular to the apparent direction of slope. The survey process continued as long as at least two instruments maintained lock on the prism. If two instruments lost lock on the prism, the wheel operator was instructed to stop until all instruments were tracking the prism. The surveyed positions were recorded using the Geolink® Data collection software developed for the U. S. Army Engineer Research and Development Center, Environmental Laboratory. After all the transects had been measured, the setup information was saved together with the site topographic data on the field computer. After the field data had been collected, it was processed using the same Geolink software and output in an Excel spreadsheet file format, with four columns (time, X-coordinate, Y-coordinate, Z-value).
